Preliminary Shoreline Stabilization Design Concepts

Kasota Island Shoreline Protection Project

Clear Lake
Steuben County, Indiana

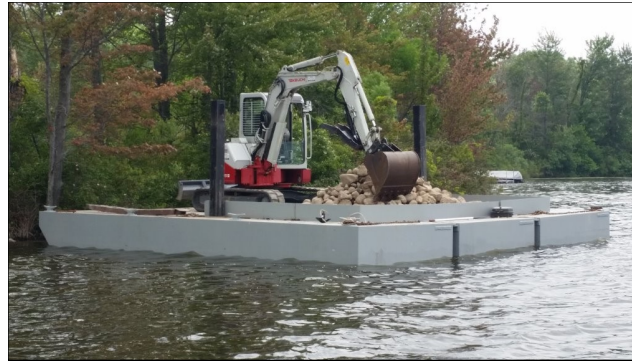
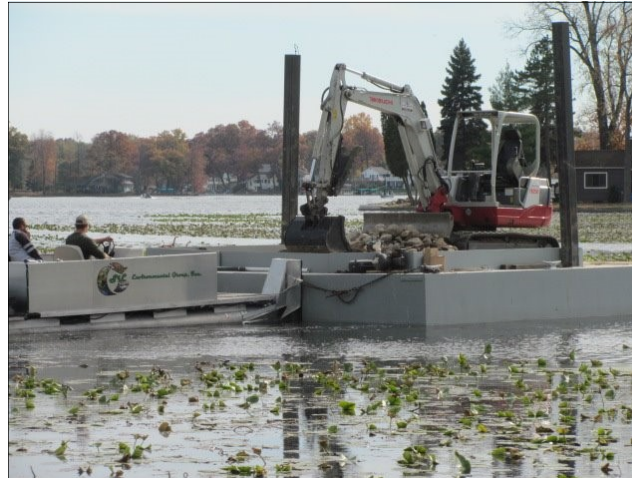
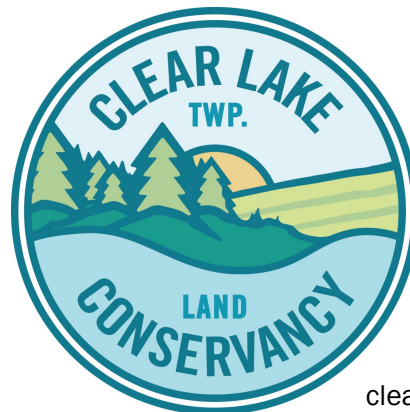
Method of Construction

Constructing shoreline restoration from barge used to transport stone, equipment, and other materials.

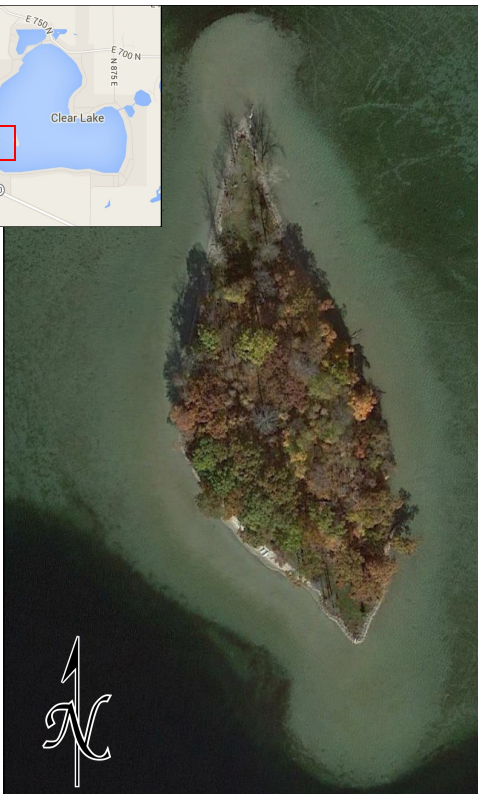
The east side of the island consists of a somewhat non-vegetated escarpment which rises 20 feet in elevation from lake level. A few shrubs and trees are growing on the steeper slope, with the density of the growth increasing at the top of the slope. The bank depth of the majority of the island is one to two feet. There is a steep hill in the middle of the island which slopes east to west and is predominately covered with woody vegetation. Water depth along the shoreline is very shallow which is evidence of the bank eroding into the lake for many years.

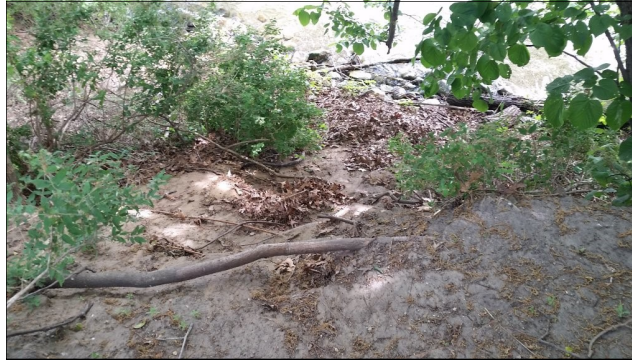
Current Condition of the Island

Past efforts to reduce the bank erosion by installing glacial stone has been helpful, but as seen in this picture, the soil and stone continue to slide into the lake as the bank is undercut by wave energy penetrating the voids in the stone and washing away the unprotected soil behind the stone.

- ◆ Protect and Stabilize the Shoreline while:
 - * Maintaining the existing topography and plant life
 - * Improving the aesthetics of the island
 - * Communicating with lake residents and lake users about the need to protect the shoreline
- ◆ Investigate and apply for potential funding sources
- ◆ Utilize the existing glacial stone
- ◆ Select a qualified Design/Build contractor
- ◆ Complete Phases I, II, III outlined below

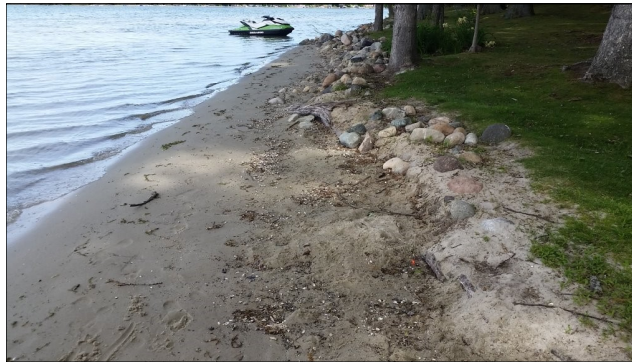
The sandy soil is eroding from behind the previously installed stone as there was not filter fabric installed under the stone to prevent erosion. The stone toe wall was not keyed into the lake bed to provide a stable foundation. The stone originally installed has slid down and is now covered with soil from the eroded bank.
